# **FLOOD PLAIN MANAGEMENT**

**A Study Of South Fork  
Shenandoah Tributaries**

**Rockingham County, Virginia**

**HAWKSBILL CREEK**

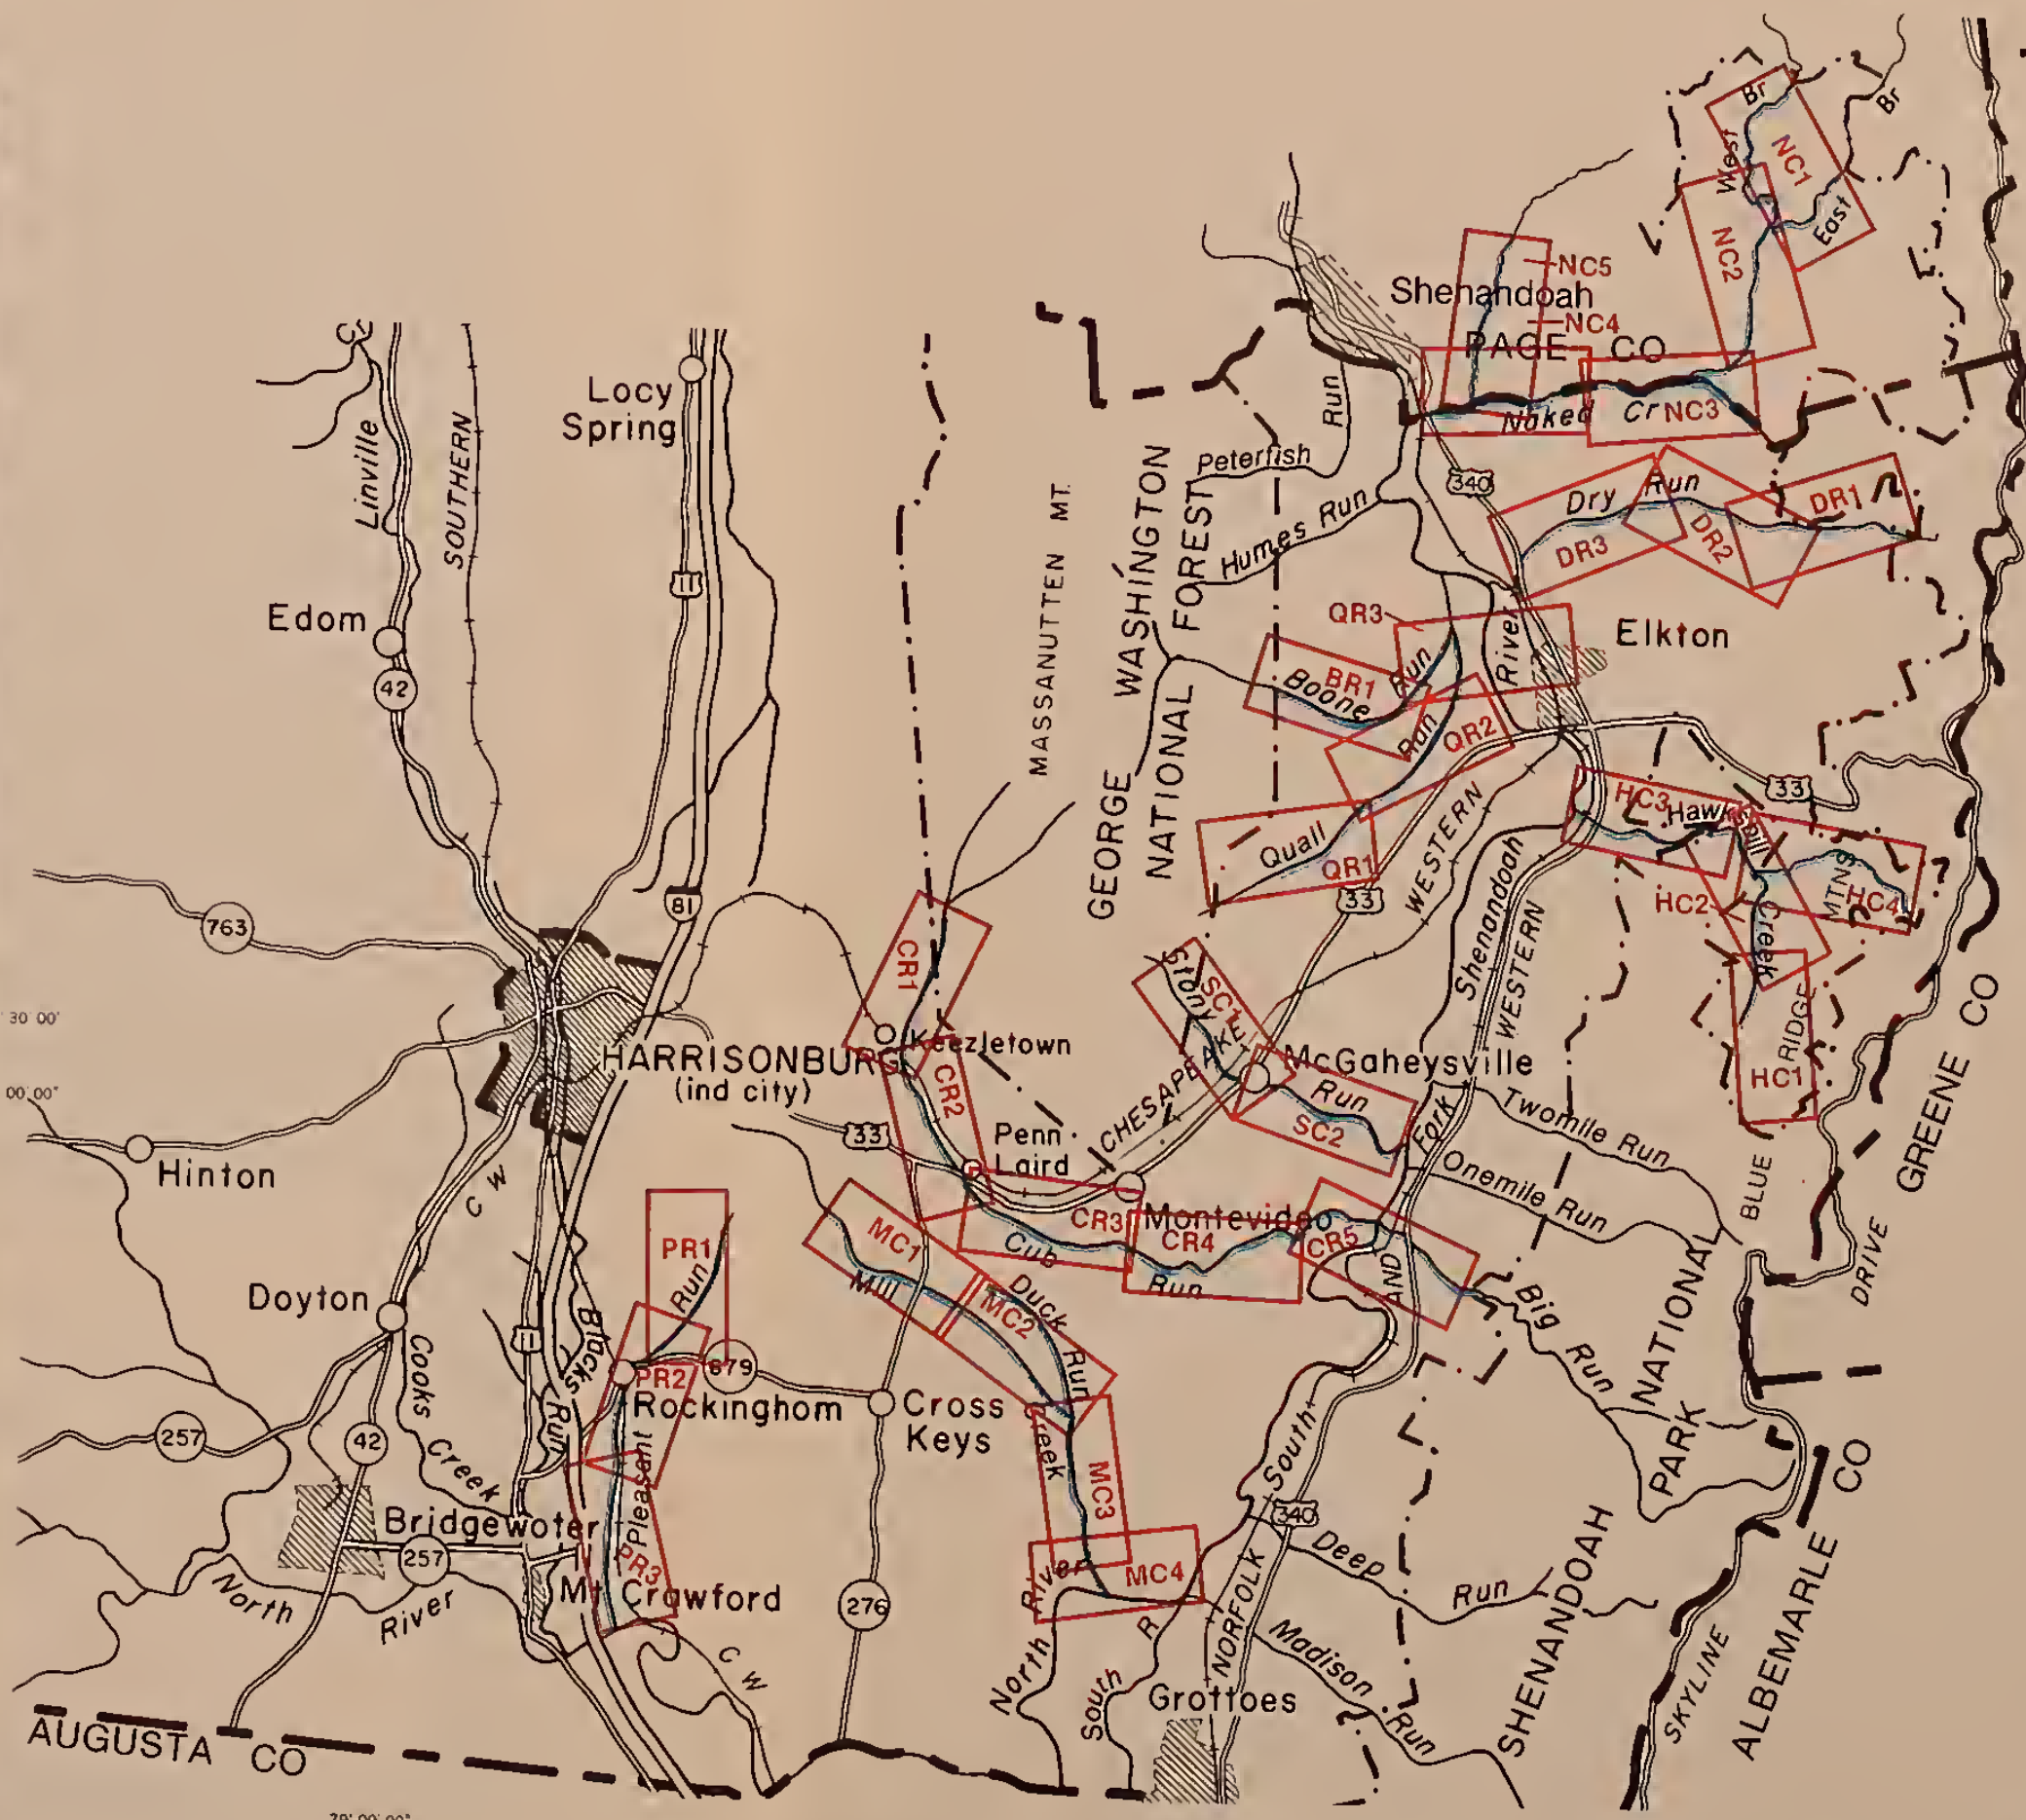
# INDEX TO PHOTOMAP SHEET COVERAGE SOUTH FORK SHENANDOAH RIVER TRIBUTARIES

The index map shows the area covered by the individual photomaps. Flood hazard photomaps show the area inundated by the 100 and 500-year floods. Where only one line is shown, there is no significant difference in the boundaries of the two flood areas. These photomaps should only be used to determine approximate flood elevations; they are based on semicontrolled mosaics and the boundaries shown may vary from the location on the ground.

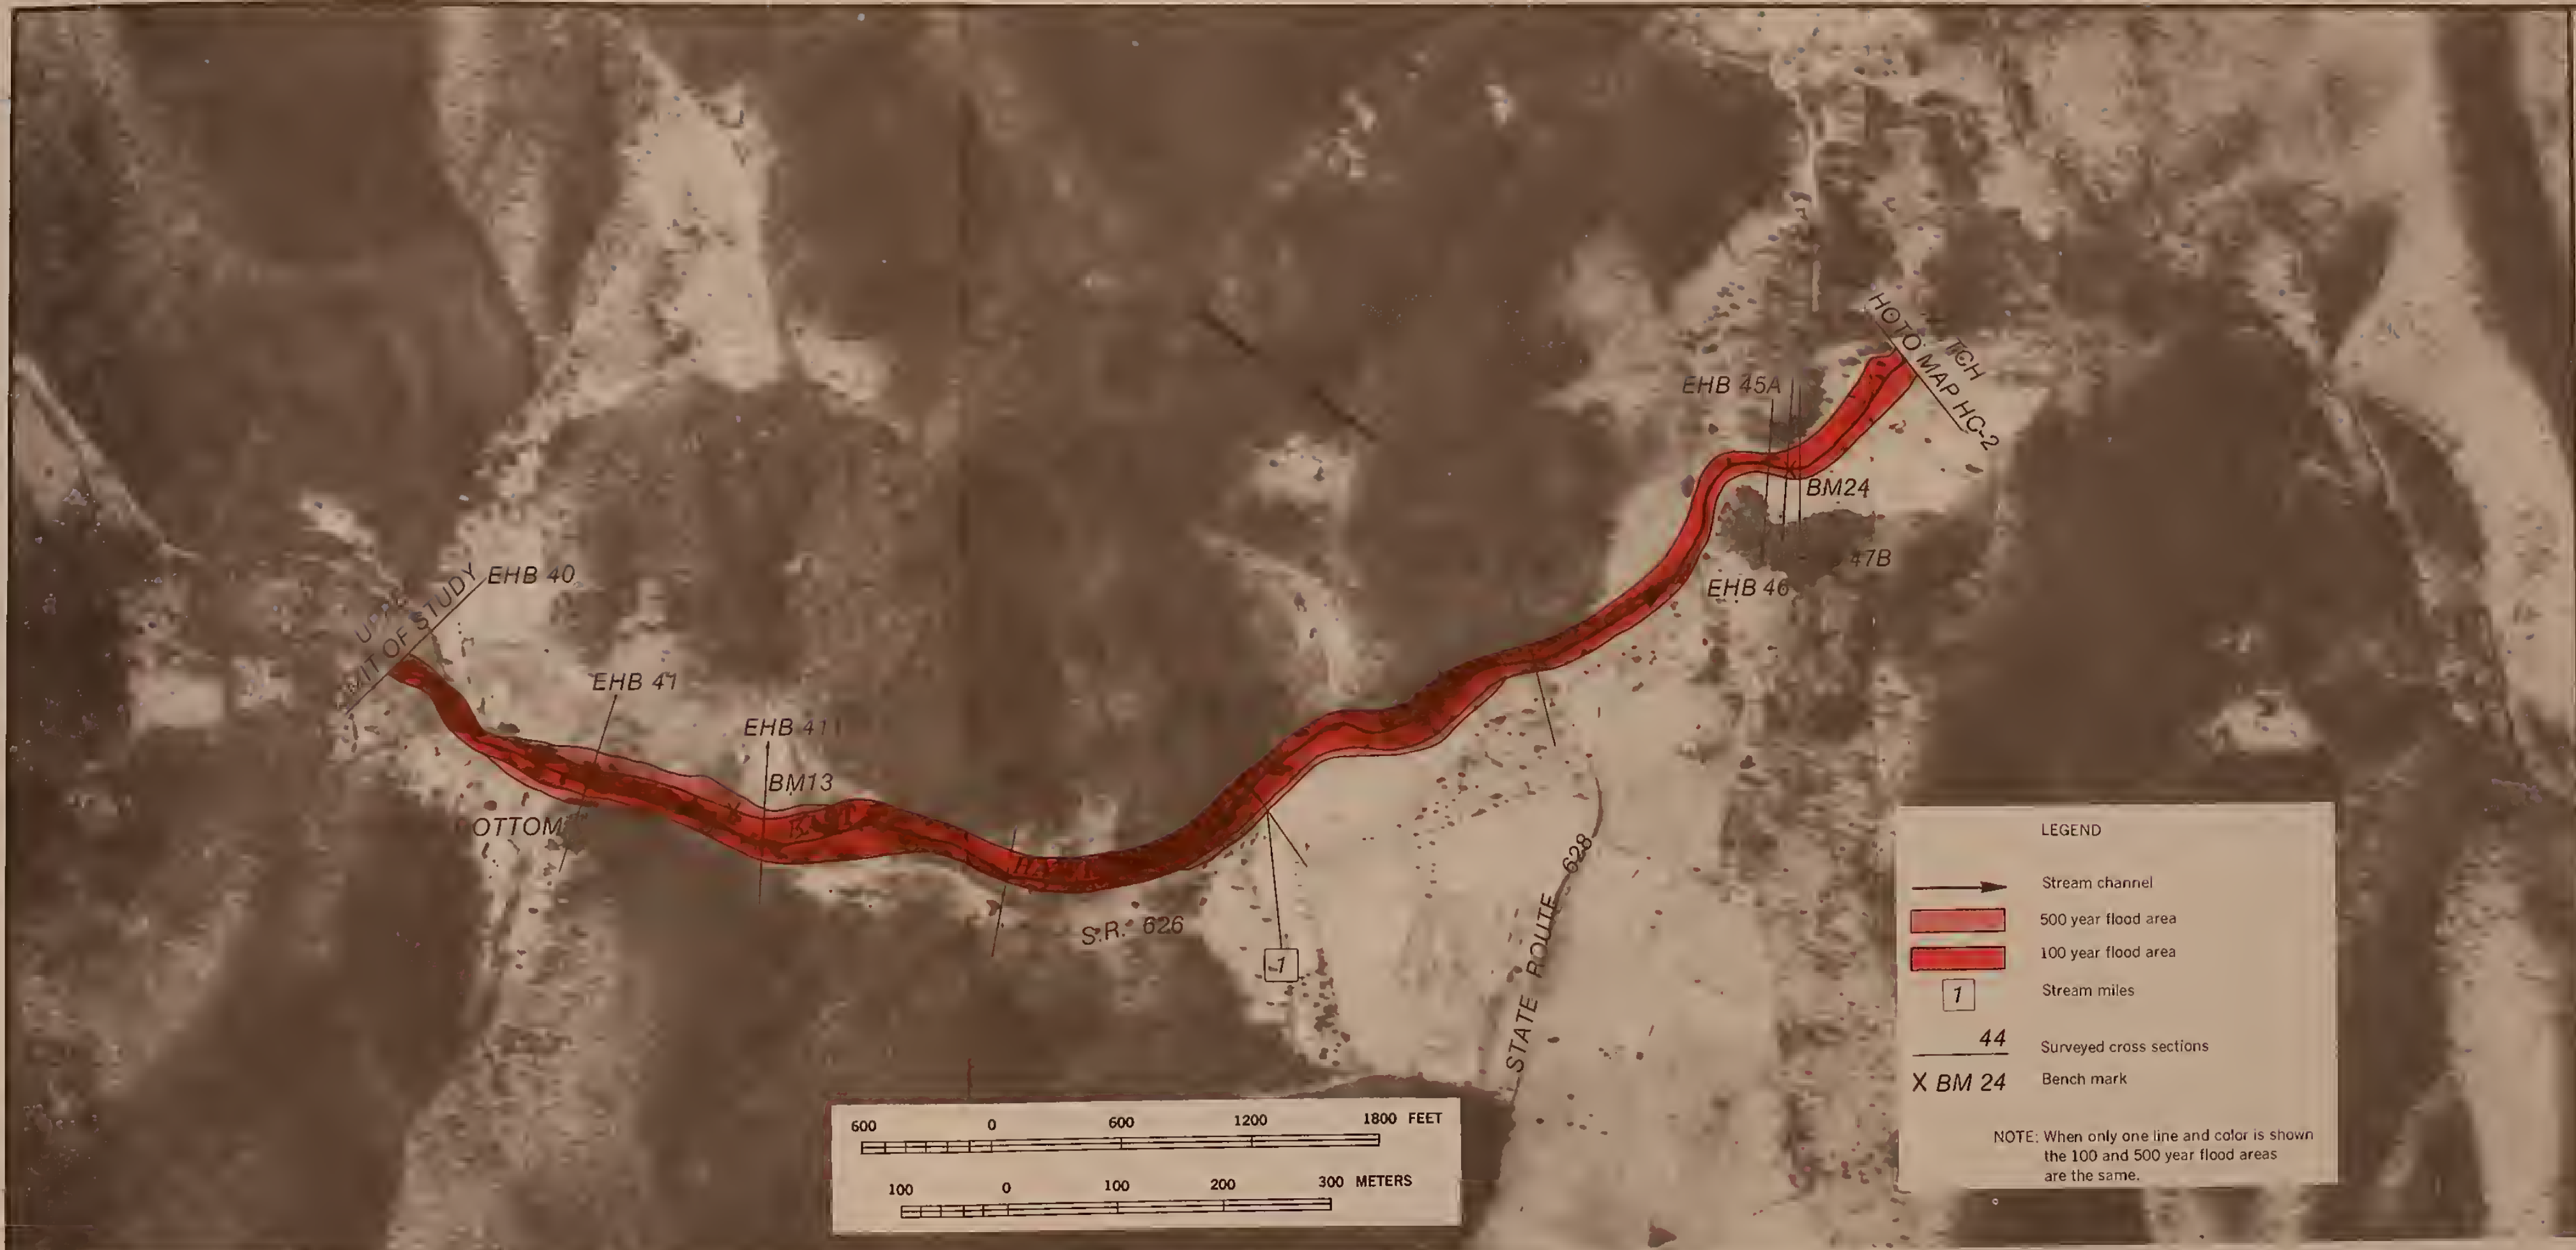
FLOOD PROFILES  
HAWKSBILL CREEK  
ROCKINGHAM COUNTY, VA.

Flood profile plates provide elevations of the 10, 50, 100 and 500-year floods at any location along the length of the streams. The elevations and discharges of the 10, 25, 50, 100 and 500-year flood at each surveyed cross section are given in Table HC-1. Sample cross sections illustrated how the flood area boundaries were located. Table HC-2 provides the description and elevation of benchmarks which are located on the photomaps.

1. On the appropriate photomap find the point on the stream where the flood line is to be located; then scale the distance along the stream to the nearest cross section.
2. On the appropriate flood profile sheet, scale the distance determined in Step 1 from the cross section back to the original stream location, and read the elevation of the desired flood frequency line.
